Fourth Road Project (Santa Elena/San Ignacio By-Pass)

Progress Report (March 2014)

Project Owner and Employer: Government of Belize, Ministry of Works (MoF)

Contract Supervision: Beca International Consultants Limited (Beca)

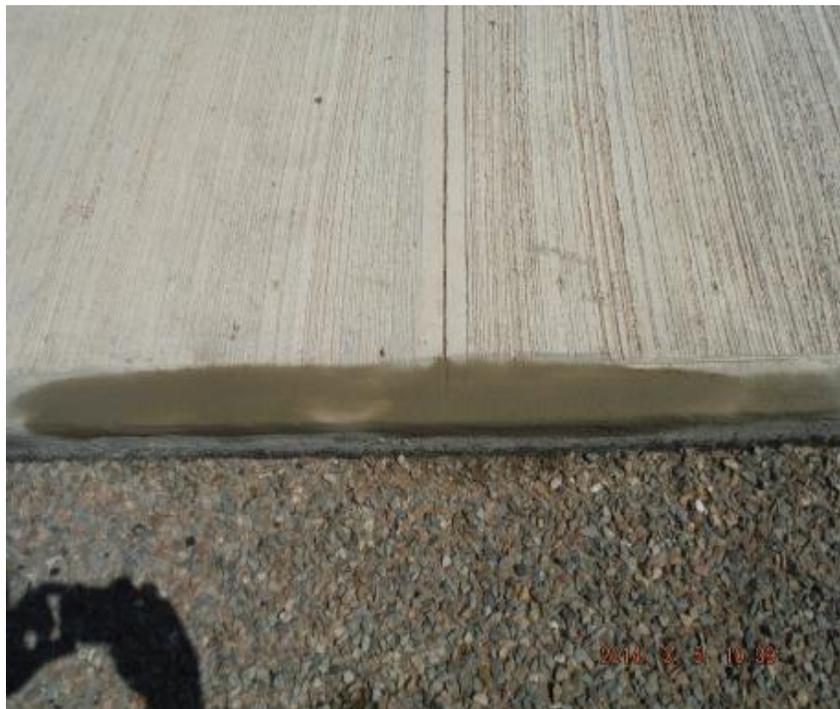
Photo 1: Loma Luz – Concrete kerb

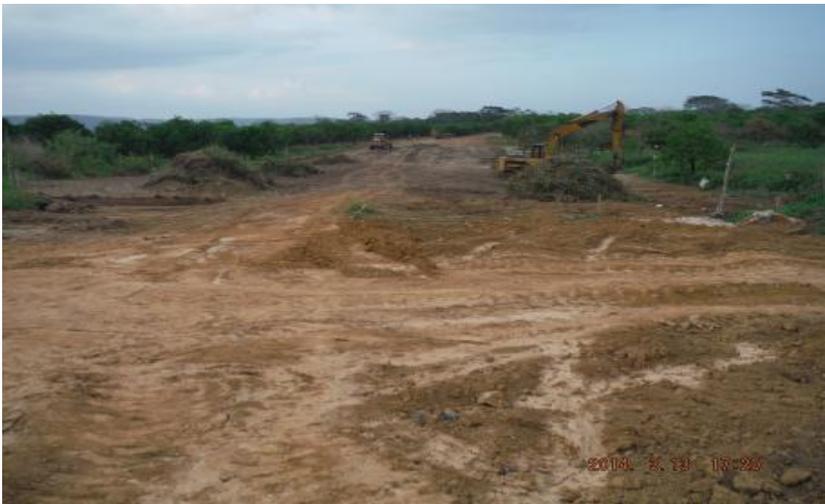
Photo 2: Branch Mouth- Clearing Site

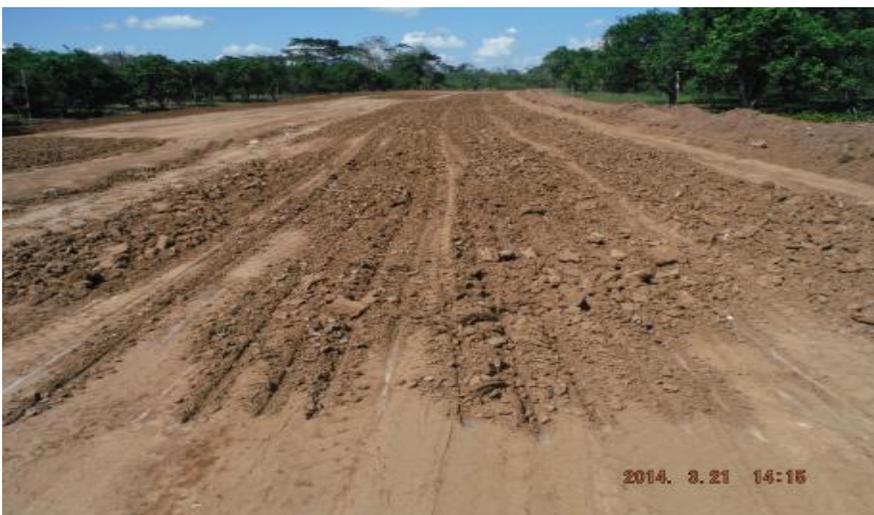
Photo 3: Branch Mouth- Sub- formation Preparation

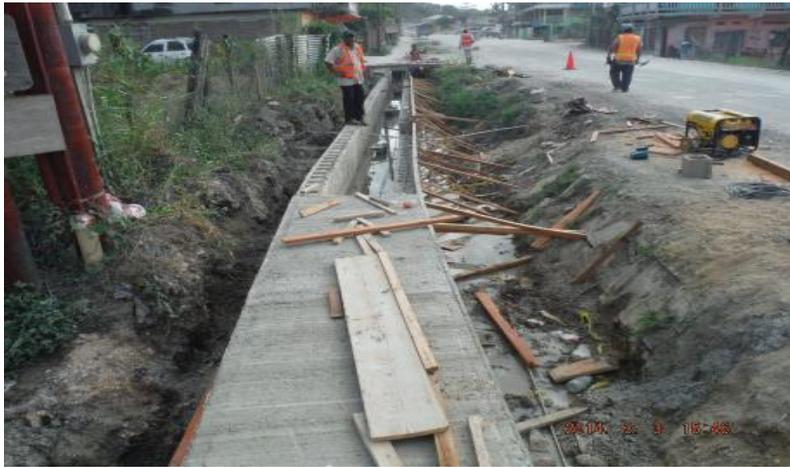
Photo 4: Joseph Andrews- Box Drain Construction

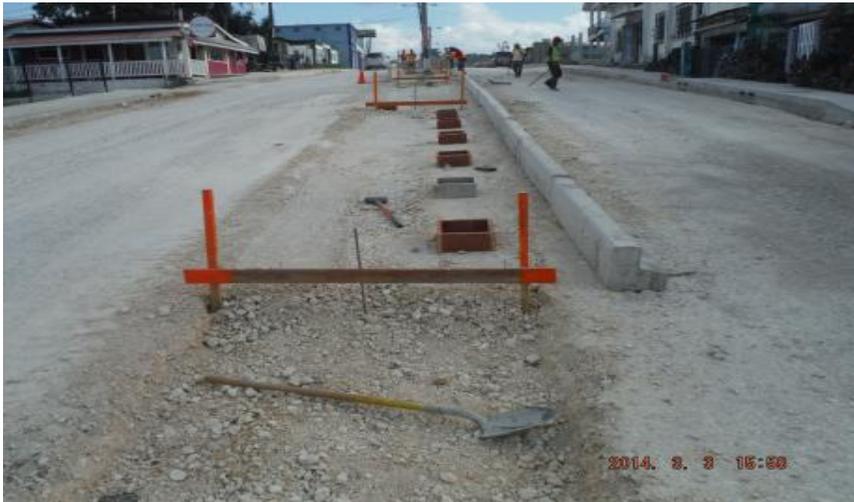
Photo 5: Joseph Andrew- Central Island Kerbing

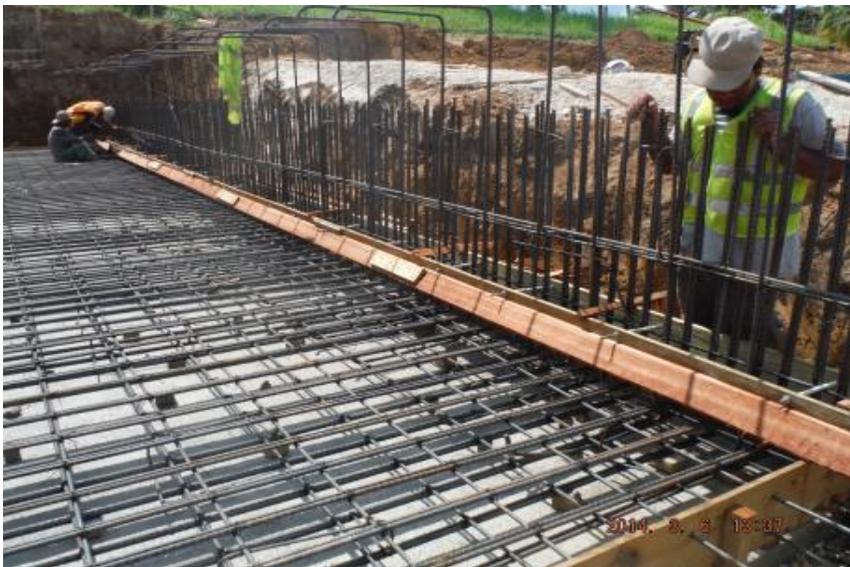
Photo 6: Joseph Andrews Culvert Reinforcing
