Fourth Road Project (Santa Elena/San Ignacio By-Pass)

Progress Report (April 2014)

Project Owner and Employer: Government of Belize, Ministry of Works (MoF)

Contract Supervision: Beca International Consultants Limited (Beca)

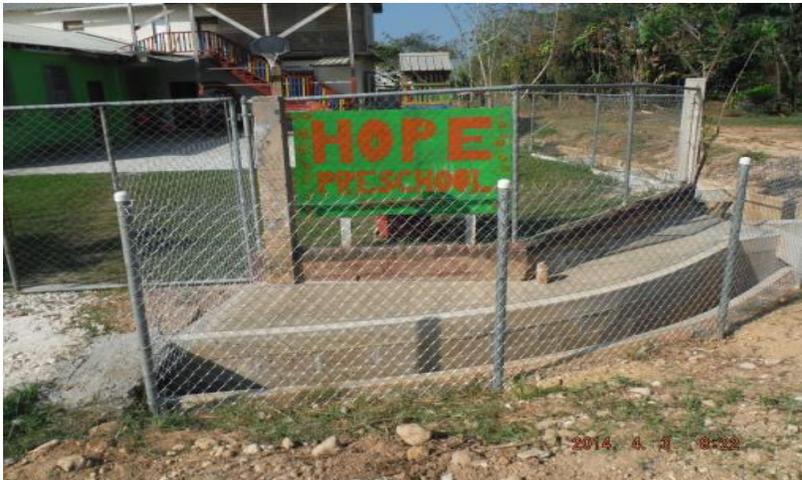
Photo 1: Loma Luz – Completed remedial to make ditch safe

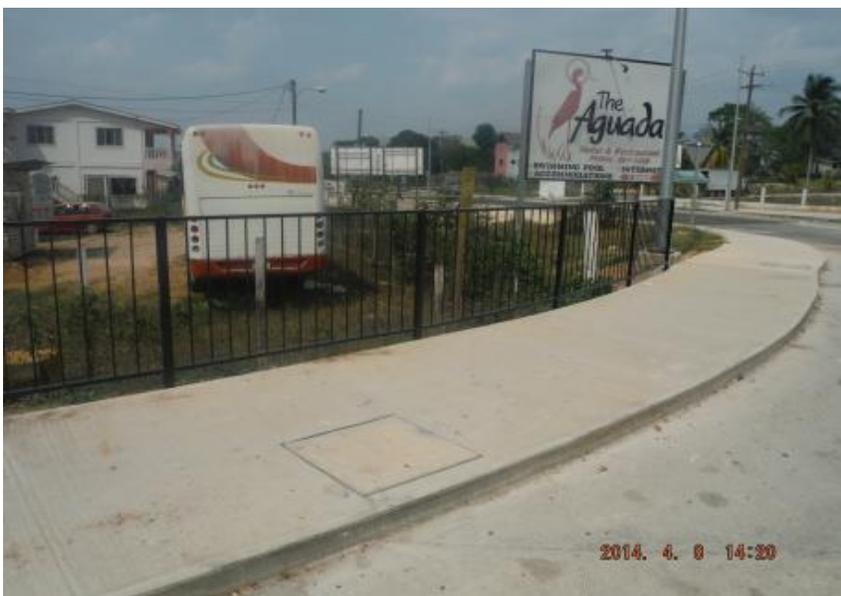
Photo 2: Loma Luz – Completed remedial to protect pedestrian from a large drop

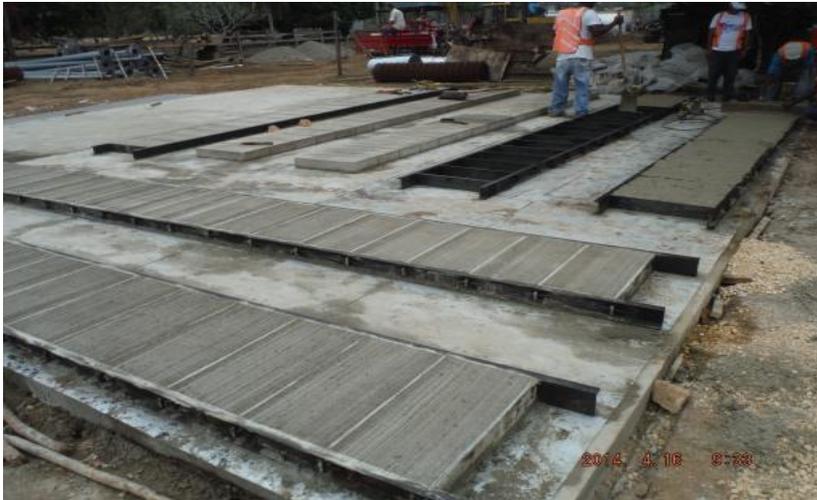
Photo 3: Branch Mouth- Casting the drainage slabs

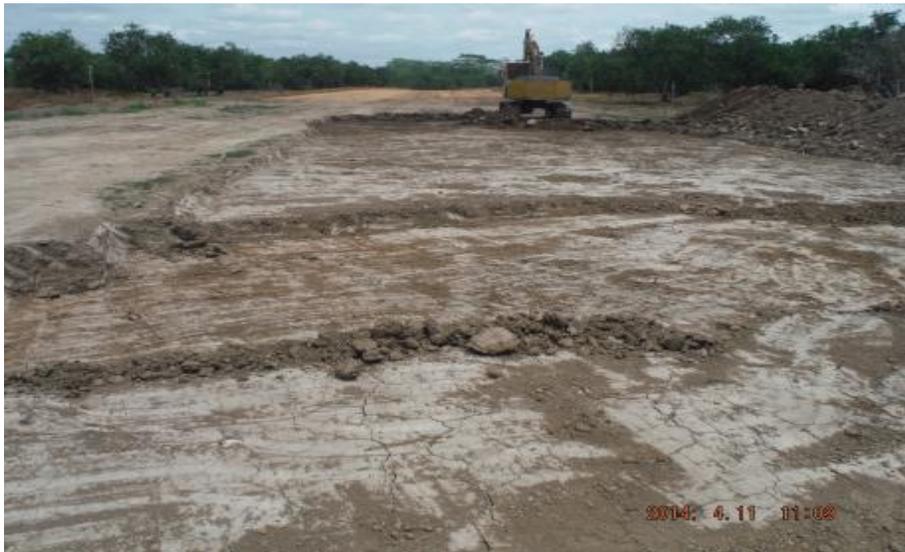
Photo 4: Branch Mouth- Preparing the formation.

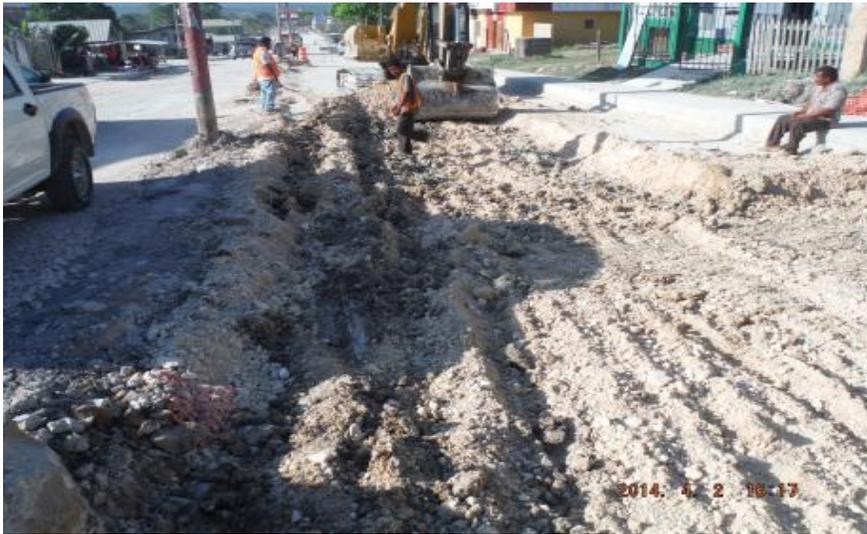
Photo 5: Joseph Andrews- Carriageway Excavation

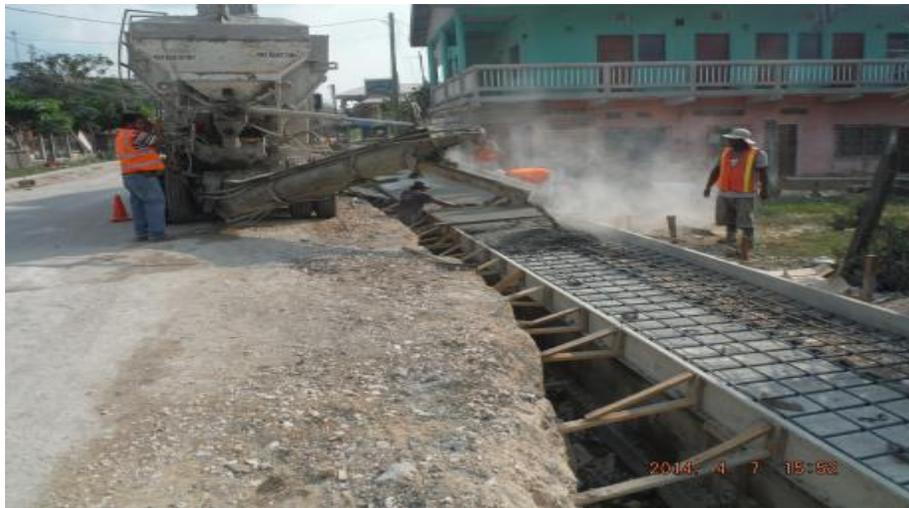
Photo 6: Joseph Andrew- Footpath Concreting

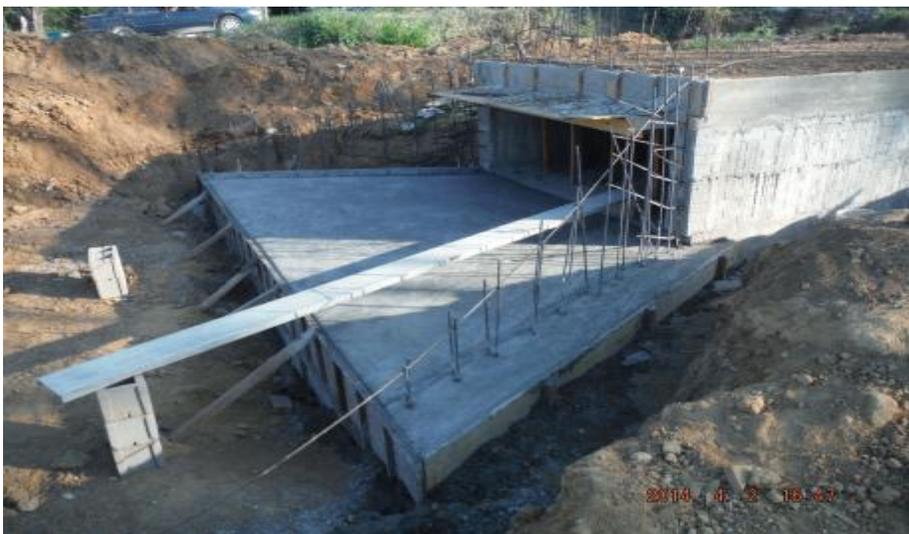
Photo 7: Joseph Andrews Culvert Reinforcing
